On Top Safety Fast Track Guard Rail System

Guard Rail Tests

REP-19010-001 REV. 0

On-Top Safety Fast-Track Guardrail System

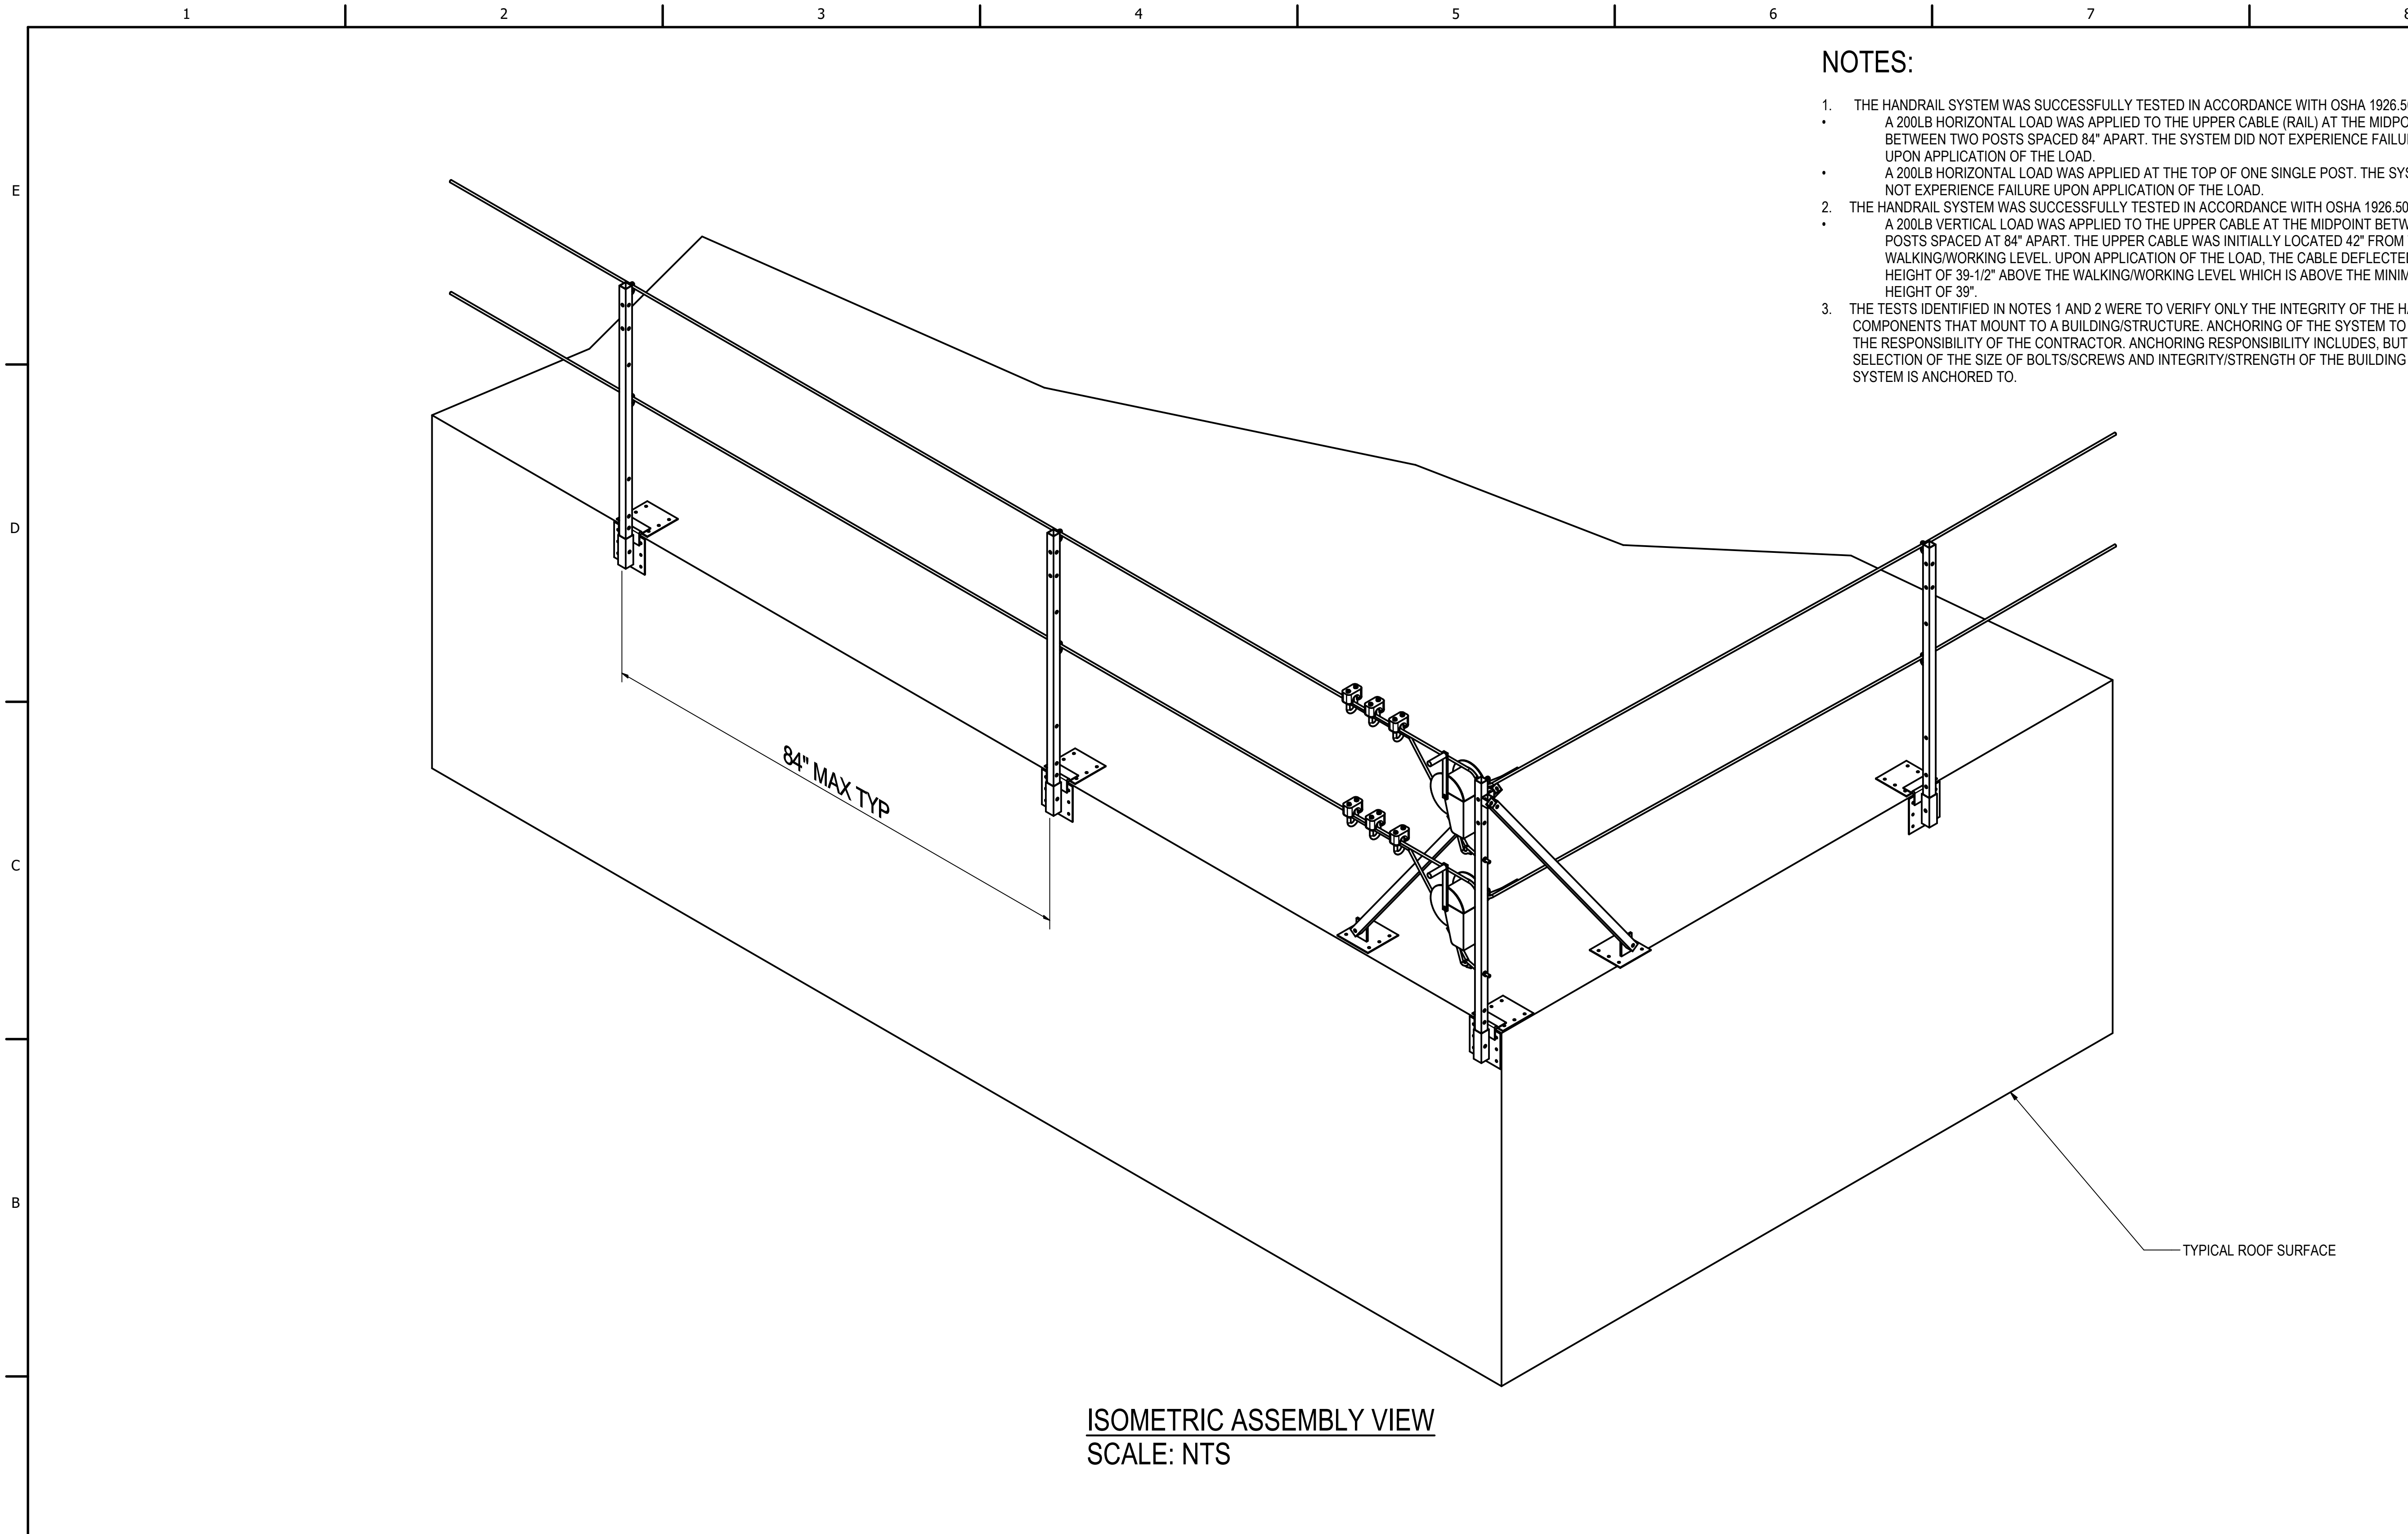
Drawing S-801

ISOMETRIC ASSEMBLY VIEW
SCALE: NTS

1. THE HANDRAIL SYSTEM WAS SUCCESSFULLY TESTED IN ACCORDANCE WITH OSHA 1926.502(b)(3).
 - A 200LB HORIZONTAL LOAD WAS APPLIED TO THE UPPER CABLE (RAIL) AT THE MIDPOINT BETWEEN TWO POSTS SPACED 84" APART. THE SYSTEM DID NOT EXPERIENCE FAILURE UPON APPLICATION OF THE LOAD.

- A 200LB HORIZONTAL LOAD WAS APPLIED AT THE TOP OF ONE SINGLE POST. THE SYSTEM DID NOT EXPERIENCE FAILURE UPON APPLICATION OF THE LOAD.
2. THE HANDRAIL SYSTEM WAS SUCCESSFULLY TESTED IN ACCORDANCE WITH OSHA 1926.502(b)(4).

- A 200LB VERTICAL LOAD WAS APPLIED TO THE UPPER CABLE AT THE MIDPOINT BETWEEN TWO POSTS SPACED AT 84" APART. THE UPPER CABLE WAS INITIALLY LOCATED 42" FROM THE WALKING/WORKING LEVEL. UPON APPLICATION OF THE LOAD, THE CABLE DEFLECTED TO A HEIGHT OF 39-1/2" ABOVE THE WALKING/WORKING LEVEL WHICH IS ABOVE THE MINIMUM ALLOWABLE HEIGHT OF 39".

3. THE TESTS IDENTIFIED IN NOTES 1 AND 2 WERE TO VERIFY ONLY THE INTEGRITY OF THE HANDRAIL SYSTEM COMPONENTS THAT MOUNT TO A BUILDING/STRUCTURE. ANCHORING OF THE SYSTEM TO THE BUILDING IS THE RESPONSIBILITY OF THE CONTRACTOR. ANCHORING RESPONSIBILITY INCLUDES, BUT IS NOT LIMITED TO, SELECTION OF THE SIZE OF BOLTS/SCREWS AND INTEGRITY/STRENGTH OF THE BUILDING MATERIAL THAT THE SYSTEM IS ANCHORED TO.

This report details the tests that were done on the On Top Safety Fast-Track fall protection guard rail system. Several tests were performed to verify that the guard rail system meets the testing requirements of 29 CFR 1926.502, Fall Protection Systems Criteria and Practices. The tests were done to verify the integrity of the handrail system components (posts, cable, struts, baseplates, etc.) as designed. The tests were not intended to verify components such as bolts/screws that attach the system baseplate to a building. Components (bolts/screws) used to attach the system to a building, integrity of the building material that it is being attached to, and proper assembly of the system is the responsibility of the contractor. Refer to Attachment A for typical configuration of handrail system.

1. OSHA 1926.502, Fall Protection Systems Criteria and Practices
2. Drawing S-801, Handrail Assembly.
